Two component polymer-modified concrete repair mortar

# Duo Patch: Ventura Promenade

Contractor: SoCal Construction | Location: Ventura, CA

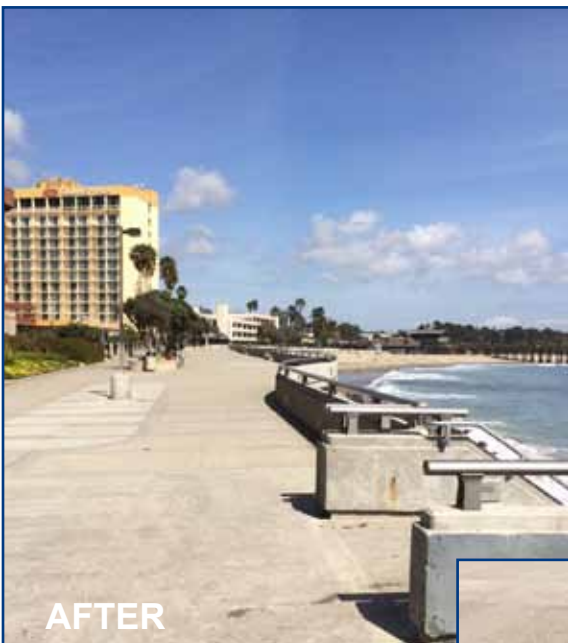
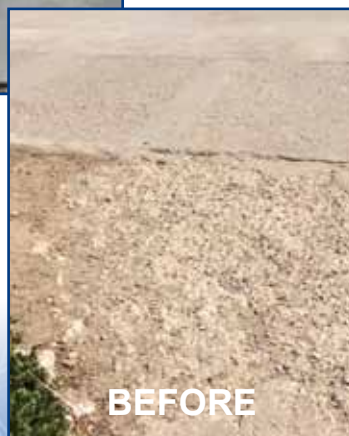
Years of sea water exposure caused severe deterioration of the original exposed aggregate concrete walkway of the Ventura Promenade. The cement mortar embedding the decorative aggregate was badly eroded and made it difficult to walk on with bare feet.

SpecChem's Duo Patch provided the solution. The durable, light gray, flowable mortar provided an easy to apply resurfacer. The Duo Patch mixed with the entire unit of admix allowed the flowable mixture to encapsulate the aggregate creating an attractive, smoother surface that will permanently bond with the substrate and can withstand the severe conditions.
