Polishing RepCon 928

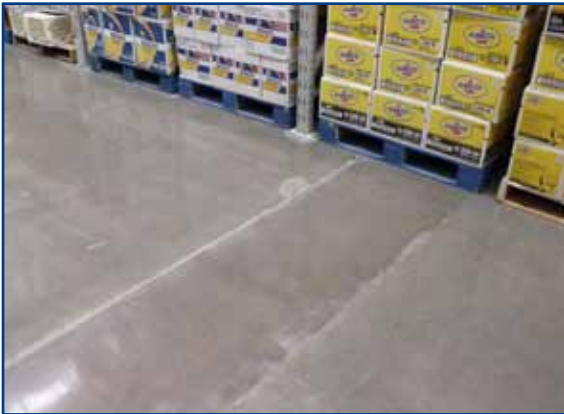
The outstanding durability, color, and density continues to open new applications for RepCon 928. One of the most popular is diamond polishing. Concrete polishing continues to grow in popularity in commercial, residential and retail applications. Very often small polished areas need to be repaired (i.e. joints, entrances, etc) where abrasion or damage from salt attack and freeze-thaw has eroded the shiny dense concrete paste. RepCon 928 offers a cost effective means of repairing these areas with a tough, rapid hardening concrete repair mortar that can be opened to traffic the next day.

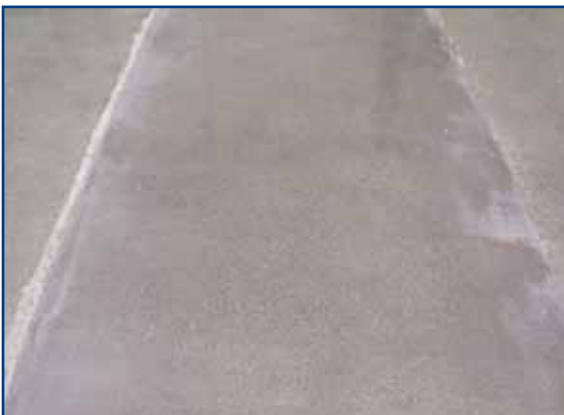
The areas to be repaired should be outlined with a saw-cut down to 3/8" – 3/4" and the damaged concrete removed down to a sound, fractured aggregate profile. RepCon 928 is then applied and finished to match the surrounding concrete and allowed to harden for a minimum of 3 days. RepCon 928 dries to a natural light gray. When repairing a colored floor, a colored stain can be applied to the cured RepCon 928 the following day to help match surrounding concrete.

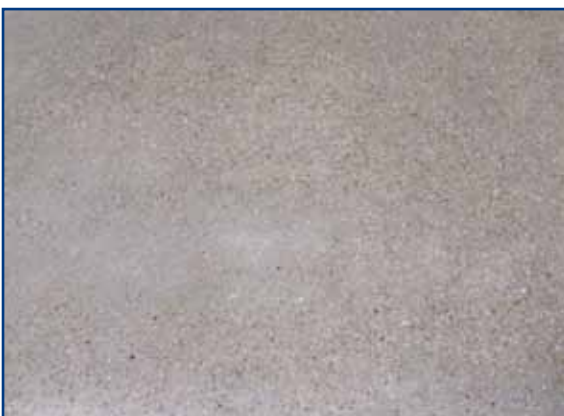
RepCon 928 also accepts integral color very well for repairing solid colored concrete surfaces. Applying SpecChem "LithSeal SC" or "SpecHard" can also help seal any porosity prior to diamond polishing to better match the surrounding concrete.
